LAKESIDE DEVELOPMENT

STAGES 1, 2 AND 3

GEOTECHNICAL COMPLETION REPORT No.1

Ref. HAM2018-0106AM Rev 5

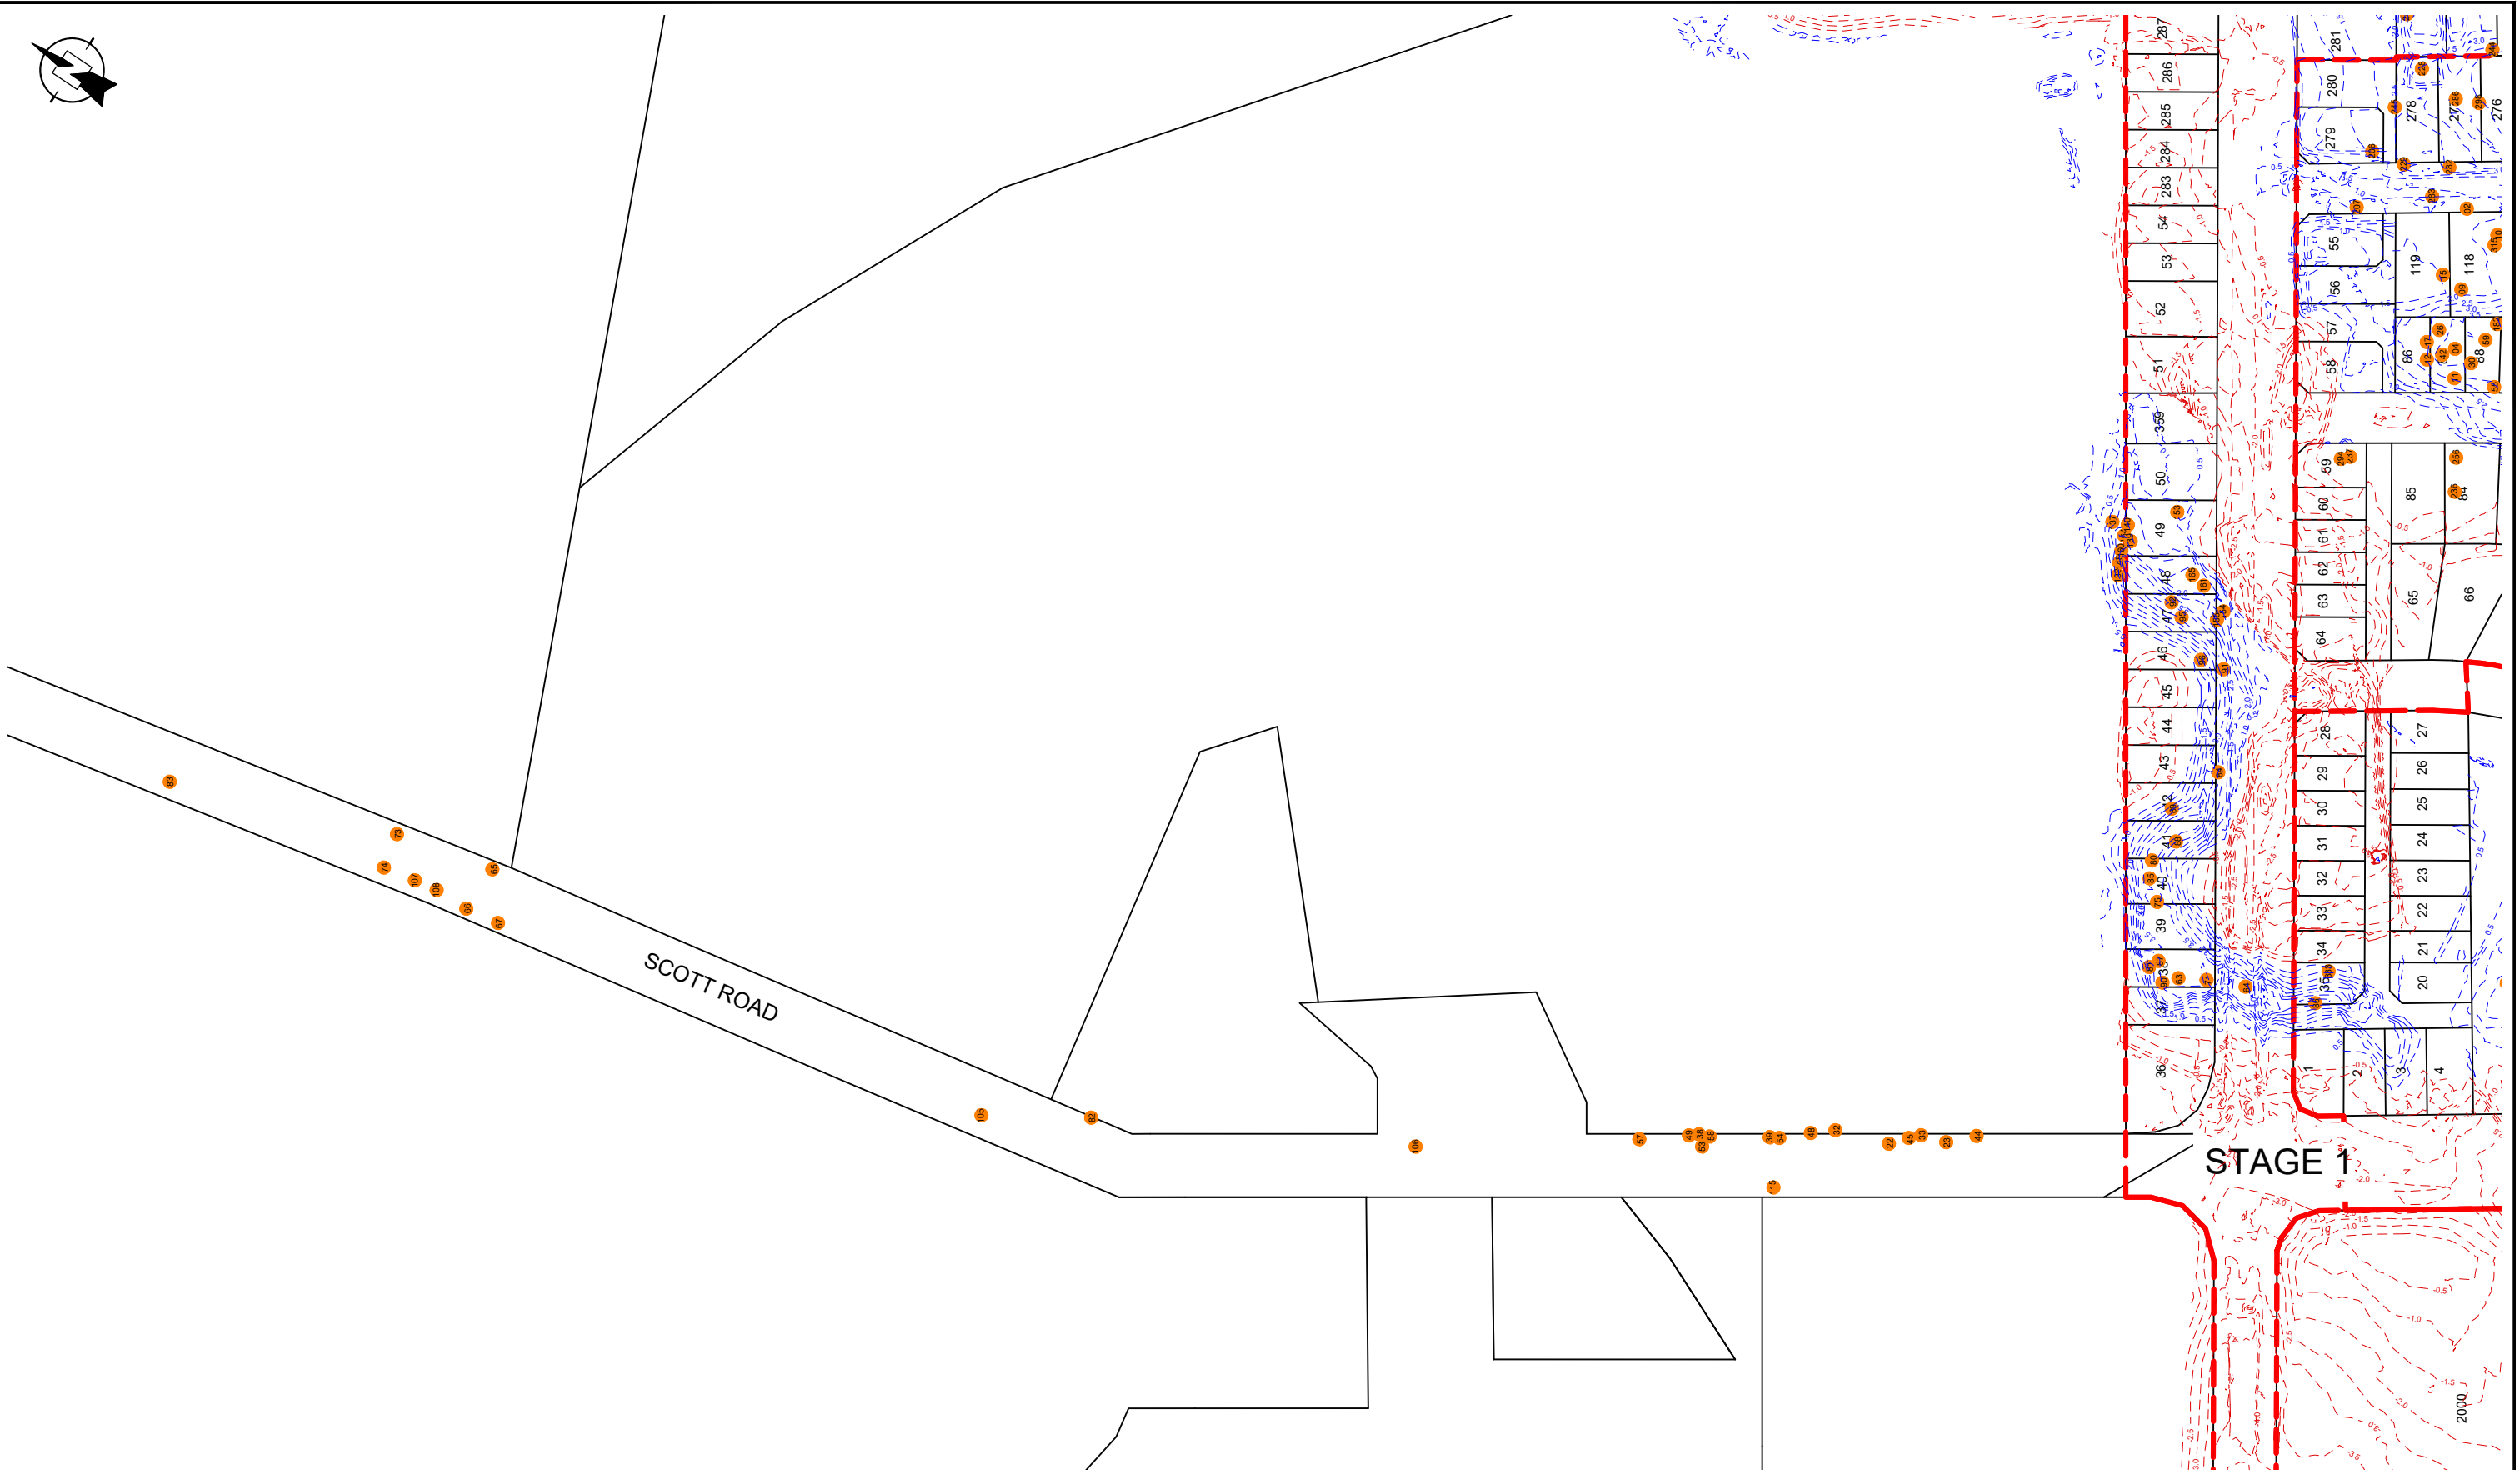
CLIENT: LAKESIDE DEVELOPMENTS (2017) LTD	DRAWN: WPJ	PROJECT No: HAM2018-0106
PROJECT: LAKESIDE DEVELOPMENT, TE KAUWHATA	CHECKED: LYK	DRAWING: 10
TITLE: FILL TEST LOCATION SITE PLAN A	REVISION: 0	SCALE: 1:3000
	DATE: 28.05.19	SHEET: A3 L

Control tests carried out on the fill showed that on some occasions the required compaction standards were not being achieved, generally due to wetter than optimum soil moisture content or inadequate compaction effort.

Results of test failures were relayed to the contractor with instructions to rework or replace the affected areas of fill until compliance with the appropriate standards were achieved.
