21 February 2020

LAKESIDE DEVELOPMENT STAGES 1, 2 AND 3 GEOTECHNICAL COMPLETION REPORT No.2

Lakeside Developments 2017 Limited Ref. HAM2019-0062AF Rev 1

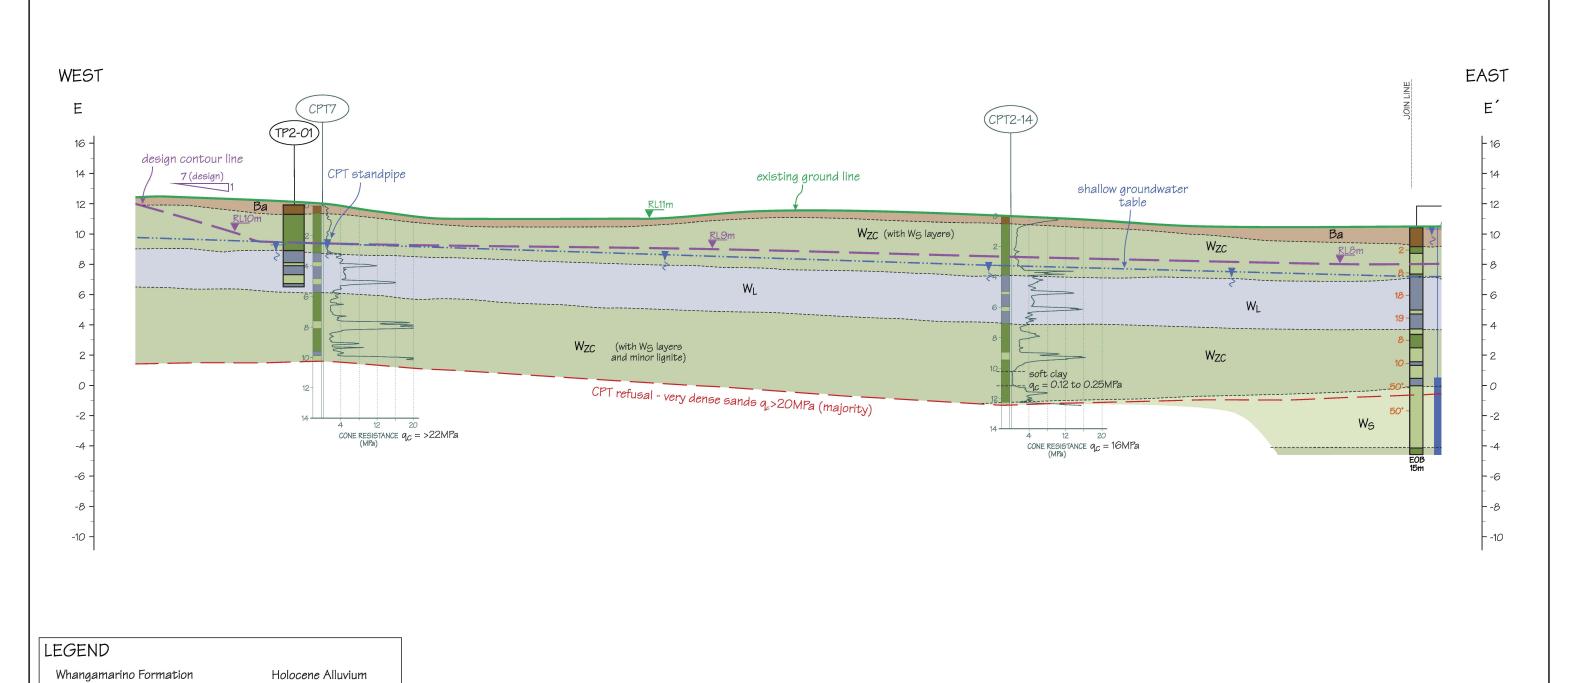
04	4 0	N = 4.1 = F	D D'			DRAWING	10.:
Stage	1 Cross S	FIG. 4.4					
DRAWN:	P.K	CHECKED	P: P:K	SCALE (A3	3):	VERSION:	Α
TRACED:	C.M/S.H	DATE:	21/12/17	1:500(h)	1:250(v)	REF:	4036

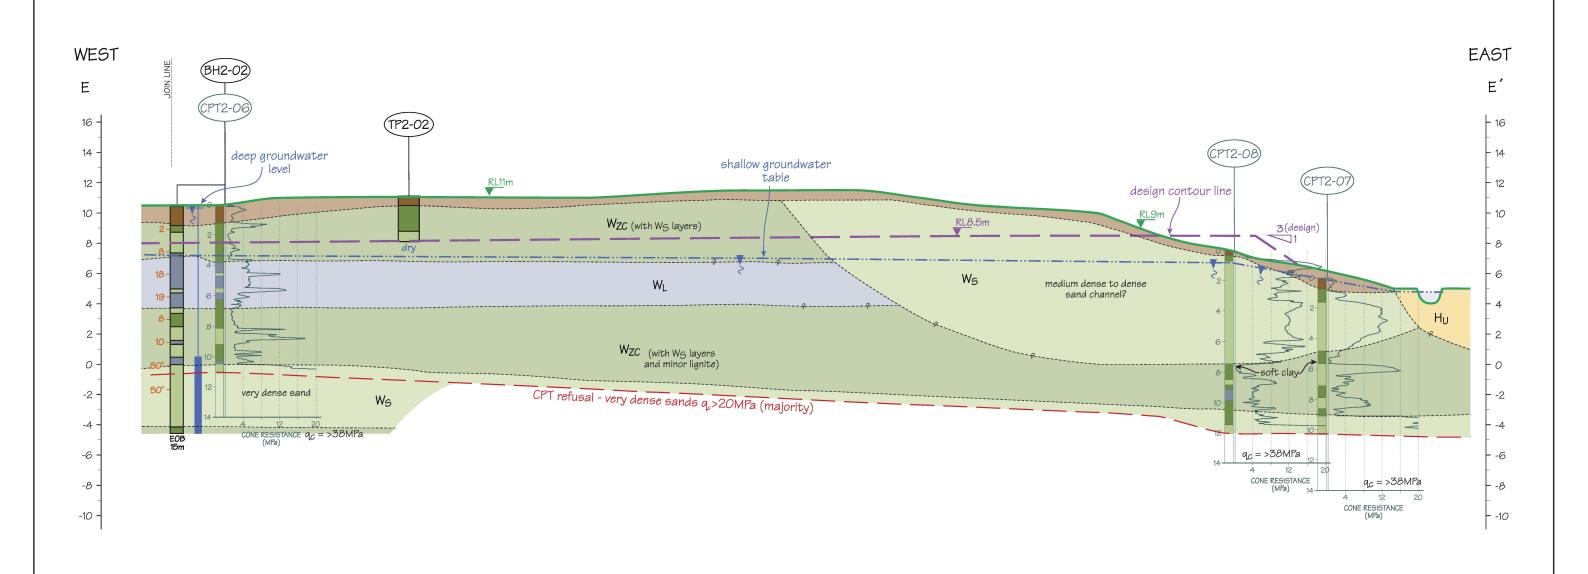
4036-AHN-R4036-4-Stage 2-Fig 4.1A_B-A

4	1036-AHN-R40)36-4-Stage 2-	-Fig 4.1A_B-	-A
		DRAWING NO.:						
Stage	2 Cross S	Section E	E-E' (Page	e 2)		FIG.	4.1B	
DRAWN:	P.K	CHECKED	: P.K	SCALE (A	3):	VERSION:	Α	
TRACED:	C.M/S.H	DATE:	17/01/18	1:500(h)	1:250(v)	REF:	4036

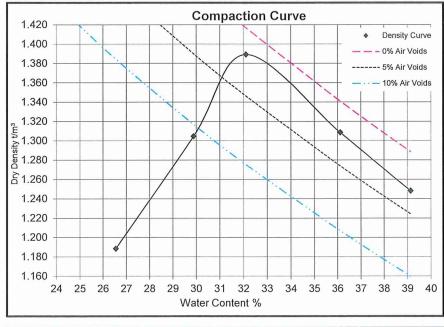
Test Results								
Maximum dry den	sity	1.39	t/m³		Natural wate	r content	32.1	%
Optimum water co	ntent	32	%		Fraction teste	ed 10	0% Passing 19	mm
Sample ID		-180	-120	-60	NAT	60	120	
Bulk density	t/m³	1.473	1.504	1.694	1.835	1.781	1.737	
Water content	%	23.6	26.5	29.9	32.1	36.1	39.1	
Dry density	t/m³	1.192	1.188	1.305	1.389	1.309	1.248	
Sample condition		Very Stiff	Stiff	Stiff	Firm	Soft	Very Soft	
•		Dry	Dry	Dry-Moist	Moist	Moist	Wet	
Peak stress	kPa	Refusal	Refusal	Refusal	119	42	24	
Remoulded stress	kPa	Refusal	Refusal	Refusal	32	13	6

Test Methods	Notes	
Compaction NZS 4402 : 1986 Test 4.1.1 (Standard)		
Shear Strength using a Hand Held Shear Vane, NZ Geotechnical Soc Inc 8/2001

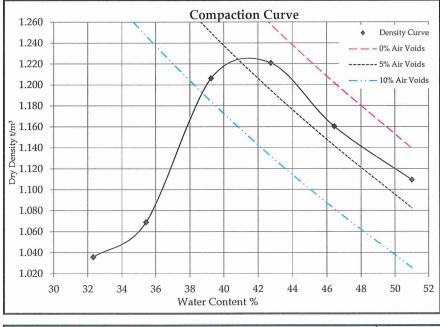
Maximum dry dens	itx	1.22	t/m³	Cest Results	Matural water	content	42.7	%
Optimum water co		41	%		Natural water content 42.7 Fraction tested 100% passing 19mn			
Sample ID		-180	-120	-60	Nat	60	120	
Bulk density	t/m³	1.370	1.448	1.679	1.743	1.699	1.675	
Water content	%	32.3	35.4	39.2	42.7	46.4	51.0	
Dry density	t/m³	1.036	1.069	1.206	1.221	1.160	1.109	
Sample condition		V.Stiff	V.Stiff	Stiff	Firm	Soft	Soft	
*:		Dry	Dry - Moist	Moist	Moist	Moist	Moist-wet	
Peak stress	kPa	Refusal	Refusal	Refusal	27	12	4	
Remoulded stress	kPa	Refusal	Refusal	Refusal	11	6	2

Test Methods		Notes	
Compaction	NZS 4402: 1986 Test 4.1.1 (Standard)		
Shear Strength usir	g a Hand Held Shear Vane, NZ Geotechnical Soc Inc 8/2001

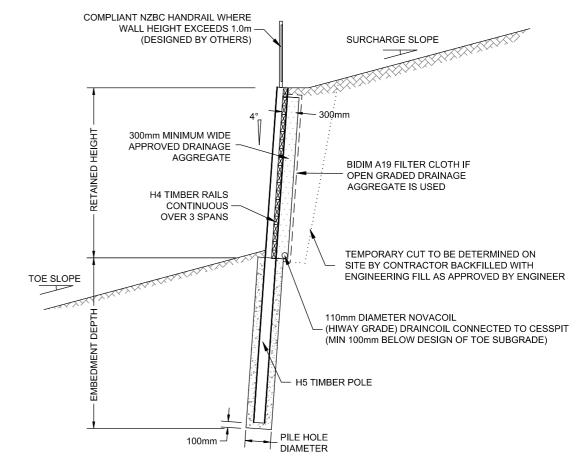
TYPICAL RETAINING WALL DETAIL

MAXIMUM SURCH	A RGE SLOPE		5	•
	MAXIMUM TOE SLOPE 5 °			•	
	FACTORED SURC	HARGE LOADING		12	kPa
	RETAINED SOIL FRICTION ANGLE 30 °			0	
	FOUNDATION SOI	IL UNDRAINED SHE	AR STRENGTH	100	kPa
	TIMBER GRADE			HIGH	
Maximum		Minimum	Minimum		
retained	Pile spacing	embedment	pile hole	Pole size	
height	C/C	depth	diameter	SED	Rail thickness
(m)	(m)	(m)	(mm)	(mm)	(mm)
1.00	1	1.3	300	150	1 x 50
1.50	1	1.9	350	225	1 x 50
2.00	1	2.5	425	275	1 x 50
2.50				350	1 x 75*

TIMBER POLE RETAINING WALL A, C AND D

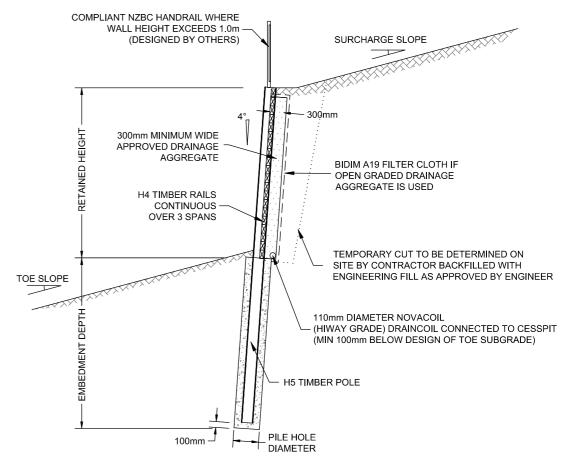
TYPICAL RETAINING WALL DETAIL

TIMBER FOLE RETAINING WALL B							
	MAXIMUM SURCH	ARGE SLOPE		5	•		
	MAXIMUM TOE SL	OPE .		5	0		
	FACTORED SURC		12	kPa			
	RETAINED SOIL FI		30	0			
	FOUNDATION SOI	L UNDRA NED SHE	AR STRENGTH	120	kPa		
	TIMBER GRADE			HIGH			
Maximum		Minimum	Minimum				
retained	Pile spacing	embedment	pile hole	Pole size			
height	C/C	depth	diameter	SED	Rail thickness		
(m)	(m)	(m)	(mm)	(mm)	(mm)		
1.00	1	1.3	300	150	1 x 50		
1.50	1	1.9	350	225	1 x 50

TIMBER POLE RETAINING WALL B
