06 May 2020

LAKESIDE DEVELOPMENT STAGES 1A, 2, 2A, 3 & 3A GEOTECHNICAL COMPLETION REPORT No.3

Lakeside Developments 2017 Limited Ref. HAM2019-0062AJ Rev 1

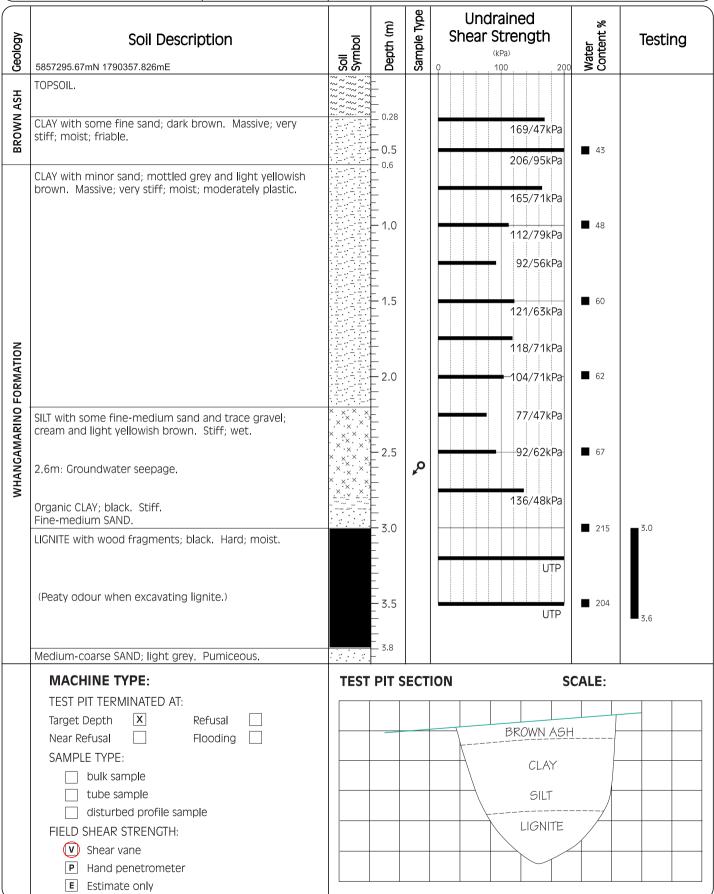
TEST PIT LOG Test Pit No.: TP2-01 Project: Lakeside Developments (Stage 2) Excavator: 12t - SB Logged by: PK Date: 09/11/17 Ref: 4036

Test Pit No.: **TP2-01 -** Page 2 **TEST PIT LOG** Project: Lakeside Developments (Stage 2) Excavator: 12t - SB Logged by: PK Date: 09/11/17 Ref: 4036 Sample Type Undrained Water Content % Depth (m) **Shear Strength** Soil Description Geology **Testing** (kPa) 200 100 LIGNITE; black. Hard; moist. 241 WHANGAMARINO FORMATION UTP - 4.5 233 UTP Fine-medium SAND with trace silt. Medium dense; pumiceous. 45 - 5.0 LIGNITE; black. Hard; moist. 168 - 5.5 EOP = 5.4mTarget depth reached. Groundwater encountered at 2.6m PK shear vane. 6.0 - 6.5 7.0 F 7.5 **MACHINE TYPE: TEST PIT SECTION SCALE:** TEST PIT TERMINATED AT: X Target Depth Refusal **BROWN ASH** Flooding [Near Refusal SAMPLE TYPE: CLAY bulk sample tube sample SILT disturbed profile sample LIGNITE FIELD SHEAR STRENGTH: (V) Shear vane P Hand penetrometer **E** Estimate only

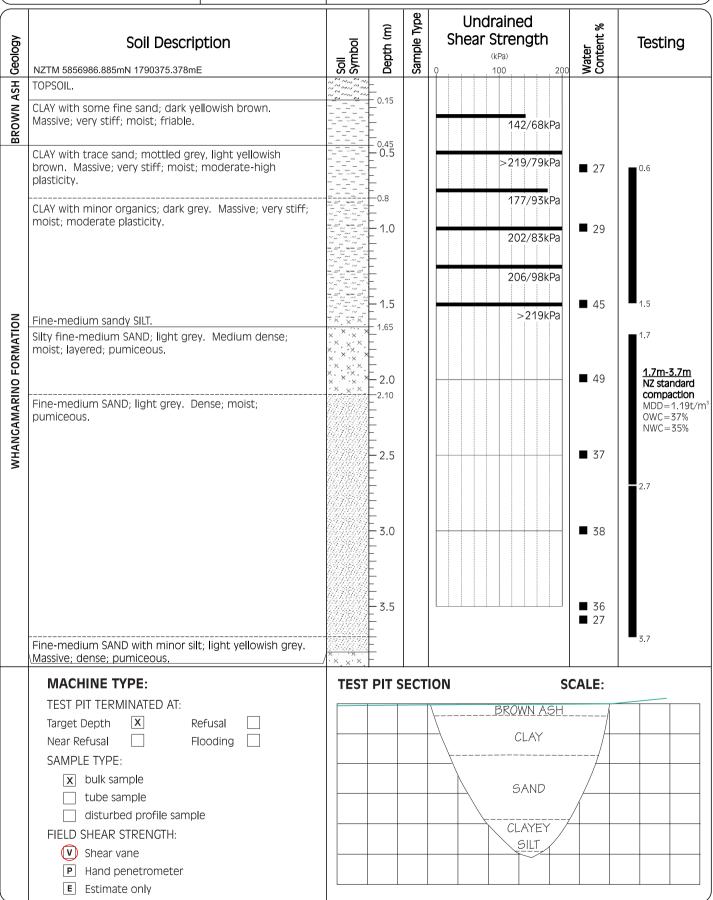
TEST PIT LOG Test Pit No.: TP2-12 Project: Lakeside Developments - Stage 1 Excavator: 12t - SB Logged by: PK Date: 09/11/17 Ref: 4036

TEST DIT	1.00	Test Pit No	Test Pit No.: TP2-12 - Page 2							
TEST PIT	LUG	Project:	Lakeside Developments							
Excavator: Logged by: PK		Date:	09/11/17	Ref: 4036						
			Ψ Use almatic and

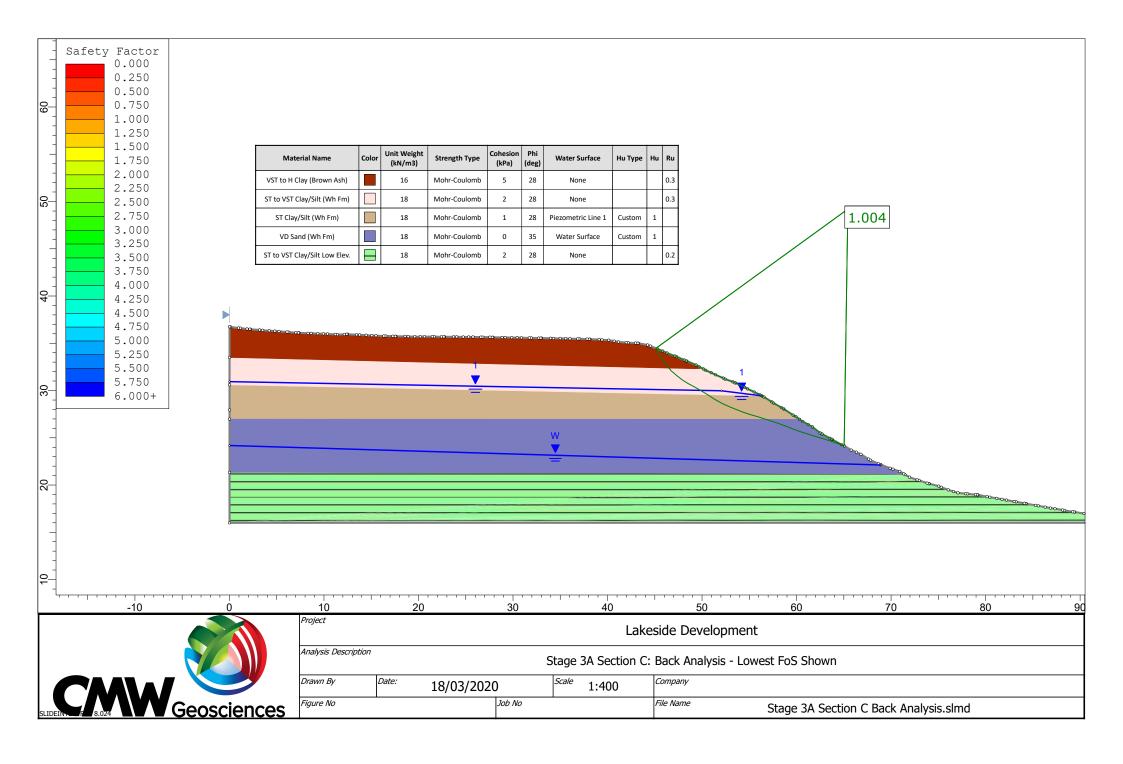
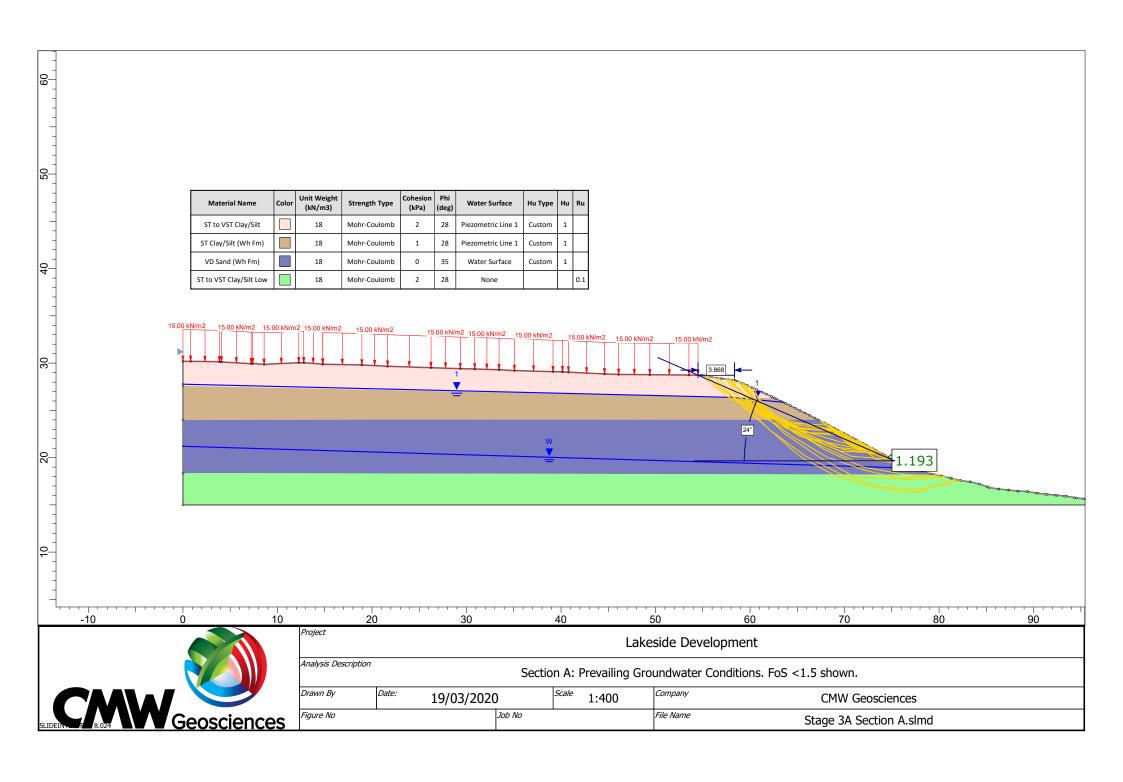
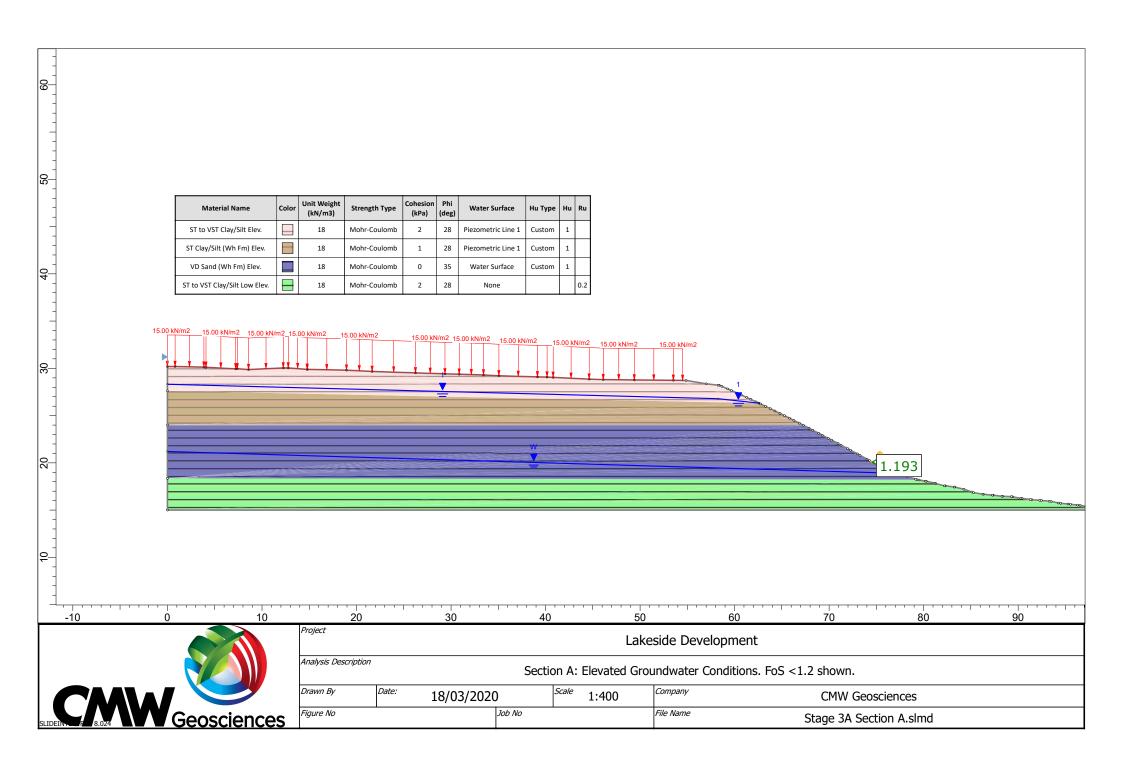
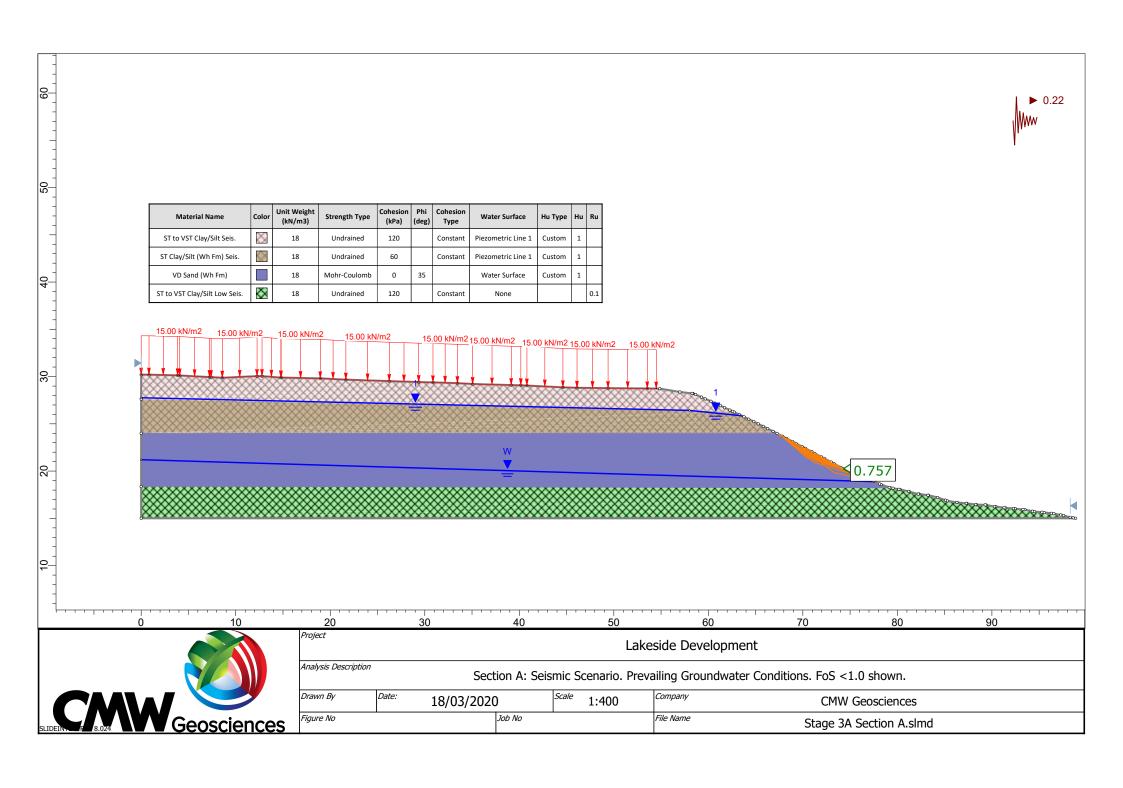
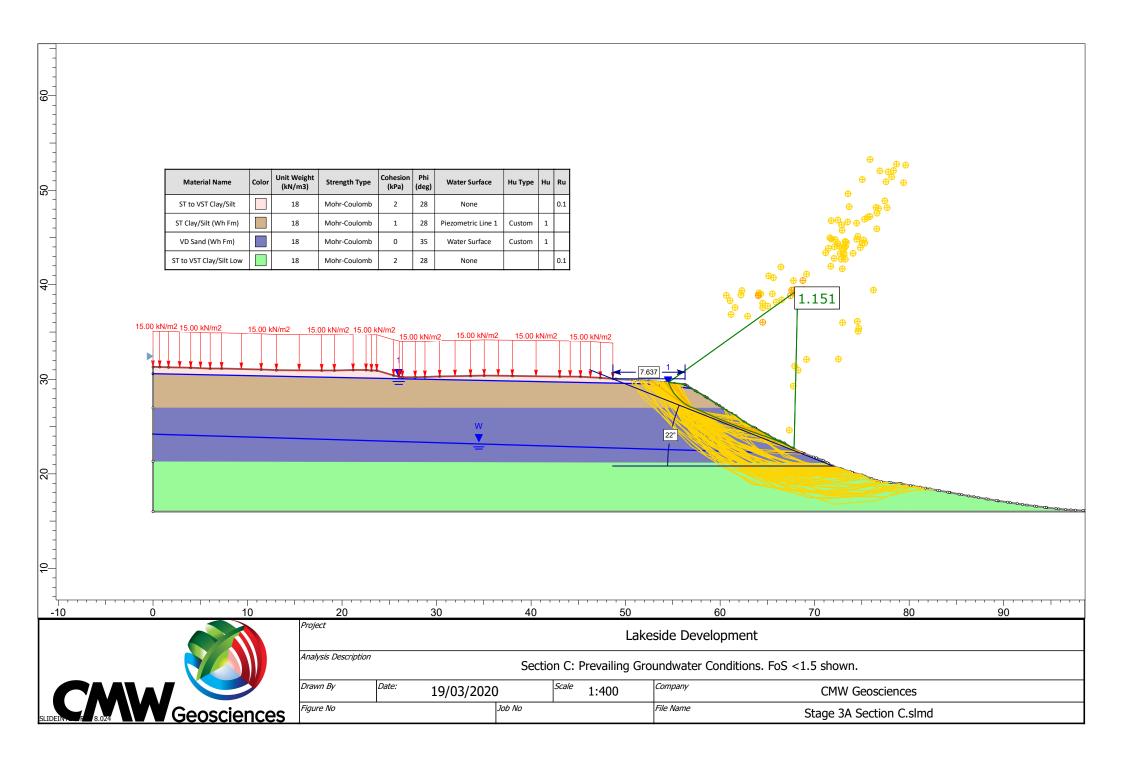
It was noted that in the location of Section C-C up to 7m of uncontrolled fill has been placed on the slope with a face angle of up to 38 degrees from the horizontal. This is not expected to have the required factors of safety and therefore is at risk of instability. The implications of this are discussed in Section 7.2.2.
