LAKESIDE DEVELOPMENT

STAGES 4 & 5

GEOTECHNICAL COMPLETION REPORT No.4

Lakeside Developments 2017 Limited

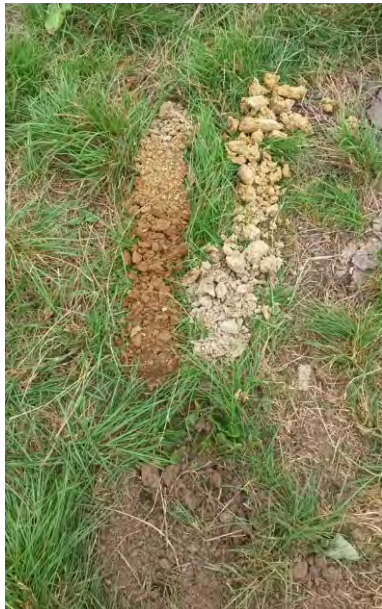
Bore No.: **HA202**

HAND-AUGER LOG

Geology	Soil Description	Soil Symbol	Depth (m)	Water Level	Undrained Shear Strength	Scala Penetrometer
					(kPa)	Blows/100mm
PUKETOKA ALLUVIUM	TOPSOIL; dry.		0.0			
	Sandy SILT; pale yellow brown. Hard; slightly moist.		0.5		UTP	
	Sandy SILT; mottled yellow, orange and brown. Very stiff; moist; plastic.		1.0		UTP	
	Fine clean SAND; pale yellow white. Medium dense; non plastic; becomes grey white with occasional orange staining.		1.5		>219/59kPa	
	Wet below 2.1m		2.0			
	EOH =2.2m bgl Target depth reached. Groundwater encountered at 2.1m. PK Shear Vane.		2.5			
			3.0			
			3.5			
			4.0			
			4.5			
			5.0
